**REPORT**  
**MRL-R-956**

**WELD REPAIR OF CRACKED DEFA**  
**CANNON MOUNT FRAMES**

The weld repair of fatigue cracks found in the mounting frames of the Defa gun pack, fitted to Mirage III aircraft, is described. These cracks, caused by normal gun firing stresses, occurred well short of the frame design life as a result of metallurgical degradation in the form of a decarburized layer on the surface of the cast steel frames.

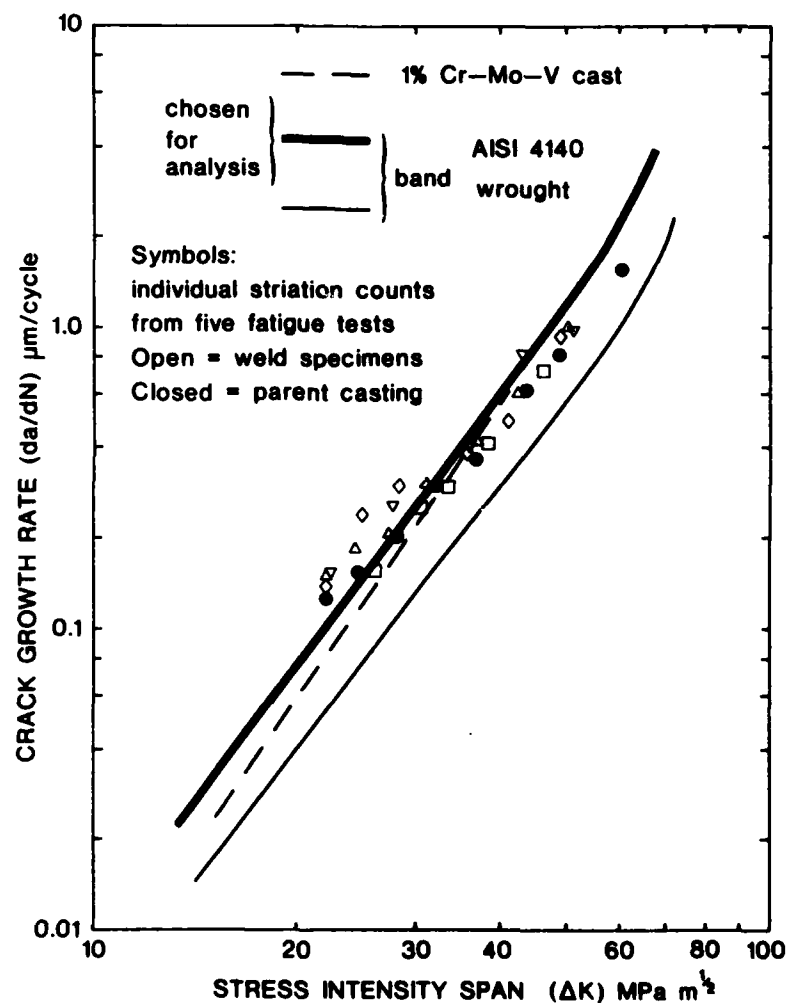
FIGURE 9

Data on fatigue crack growth rate, taken from the literature, tended to be similar for both wrought and cast low alloy steels of the Cr-Mo type, provided that they were tempered to about the same yield strength and the fatigue tests were conducted in air and with similar  $R$  values\*. Of the results used in Fig. 9 [4,5], the upper-bound curve (shown as a bold line) was adopted for analysis, to make allowance for significant shrinkage porosity in the casting (Fig. 10). The presence of such porosity would have had the effect of raising the overall macroscopic crack growth rate above that indicated by the striation spacings because of numerous local jumps across the voids.

single crack having the same total depth. The results of five tests covering parent casting and weld HAZ, over a wide range of loads, are superimposed on Fig. 9.

Fatigue crack growth rate data for 1% Cr low alloy steels. The 1% Cr-Mo-V cast steel is after Haigh [4] and the band for AISI 4140 is after Thielen and Fine [5]. Test data points are from four welded specimens (open symbols) and one parent specimen (closed symbol).

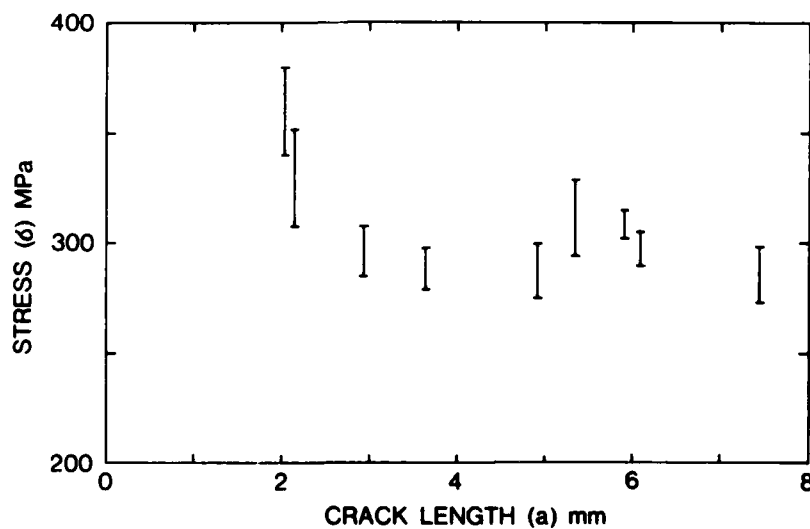
FIGURE 11

The results in Table 3 are presented graphically in Fig. 11. Despite considerable scatter in fractographic measurements, a reasonably confident estimate of  $300 \pm 30$  MPa for crack driving stress is obtained provided that two values from measurement at  $a = 2$  mm (where measurement was more difficult) are given less weighting. The scatter bars in fact reflect

Estimates of the fatigue crack driving stress in the cast frame based on measurements of the crack shown in Figs. 7 and 8.

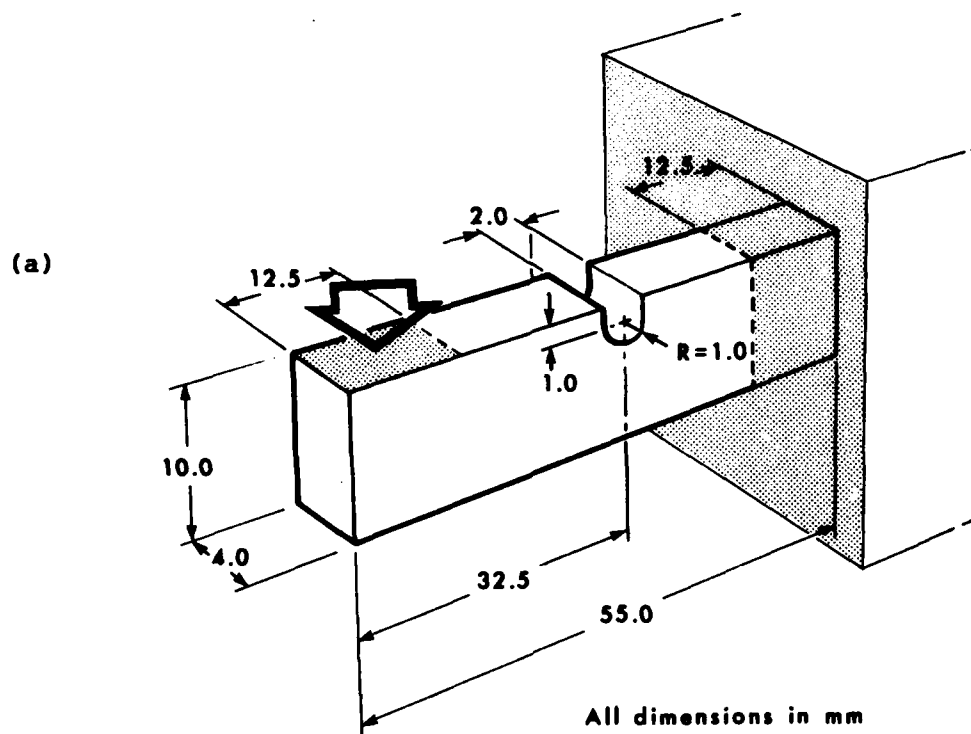
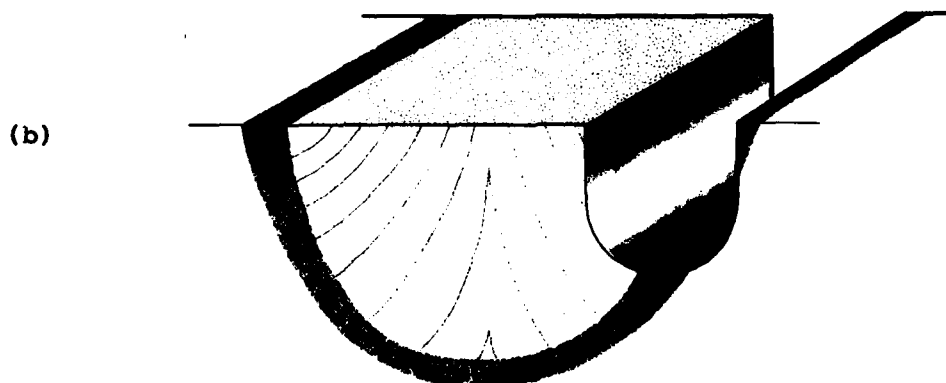
The value of 300 MPa crack driving stress, and the stress ratio  $R=0$  were used as a basis for designing fatigue test specimens and test load levels. The tests used cantilever bend specimens to simulate the loading on the bracket, and with transverse grooves to provide a known stress concentration factor of 1.6 [7,8]. Specimen dimensions are given in Fig. 12. Values of stress amplitude were obtained from surface strains measured under dynamic conditions by strain gauges bonded to the surfaces of a dummy test specimen.

Specimens were either of sound parent material, or had single-pass welds with the grooves along the fusion boundary to sample the most susceptible microstructure (Fig. 12b). In addition to generating conventional S-N fatigue life curves, tests were continued beyond the point of crack initiation in order to obtain crack growth data under known stresses.

FIGURE 12 (a) Detail of fatigue test specimen.

(b) Location of notch in welded test specimen, with the root radius of the notch in the weld heat-affected zone.

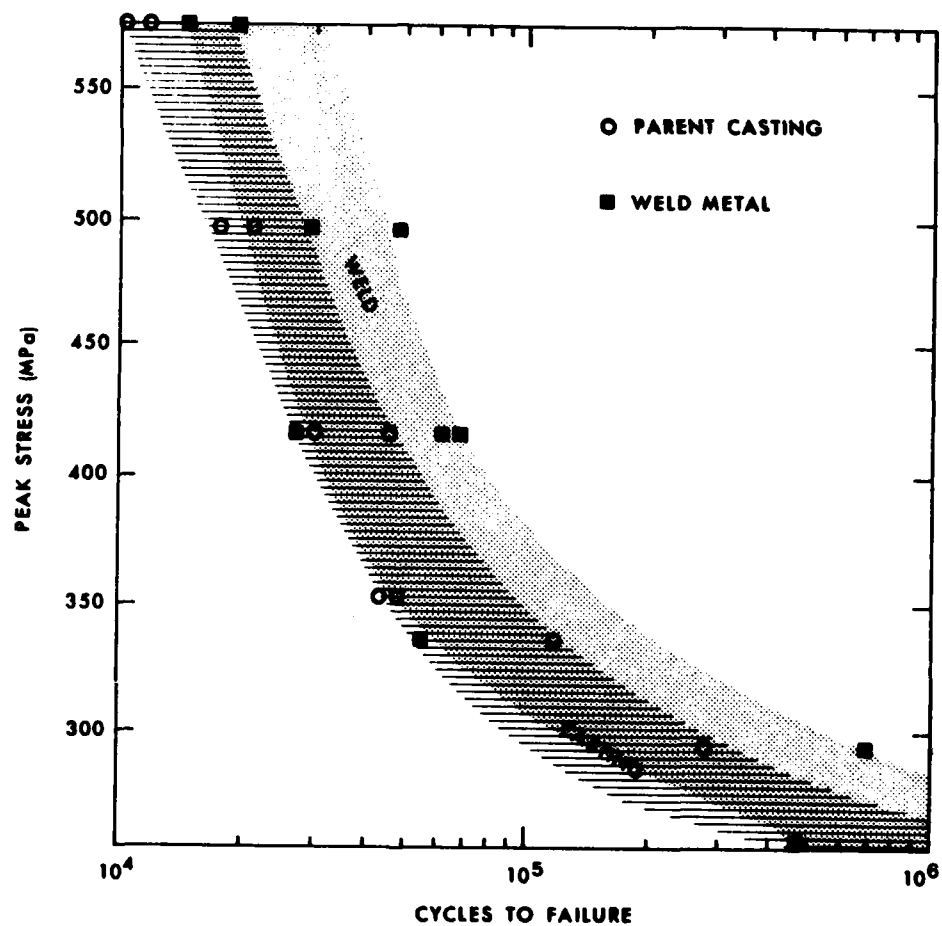
FIGURE 13

The number of test specimens was limited by the amount of material available from frames and, as a result, the S-N data are fewer than desirable for a high level of confidence. Nevertheless, the two bands of results (Fig. 13) show a high degree of consistency and overlap closely. The slight improvement apparent in the weld metal property is encouraging, but not experimentally significant.

Fatigue S-N data generated for sound casting material and from as-deposited Ni-Cr-Mo weld metal.
